Docket No. 217 – Development and Management Plan Inspection

Northeast Utilities Service Company Certificate of Environmental Compatibility and Public Need for the construction of a 345-kV electric transmission line and reconstruction of an existing 115-kV electric transmission line between Connecticut Light and Power Company's Plumtree Substation in Bethel, through the towns of Redding, Weston, and Wilton, and to the Norwalk Substation in Norwalk, Connecticut.

Date: August 10, 2005

Location: 115 kV Underground Route

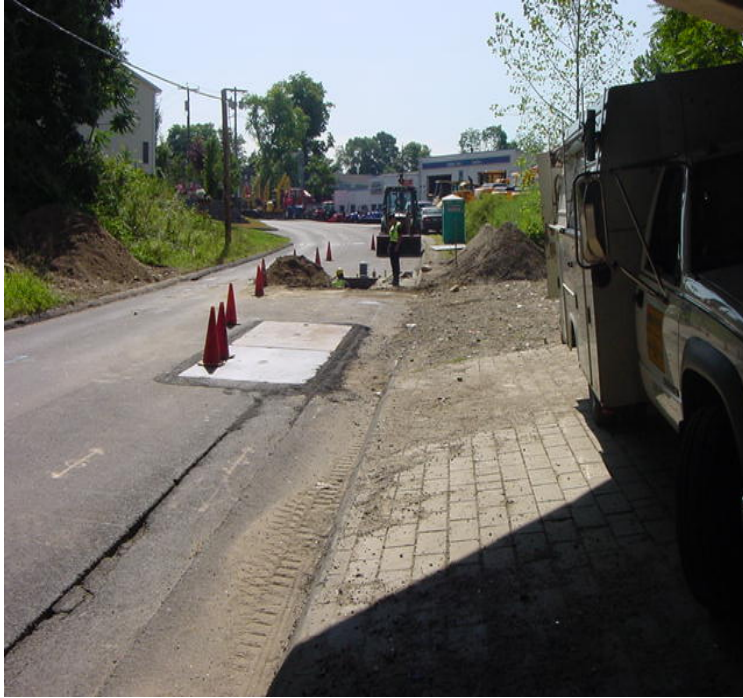
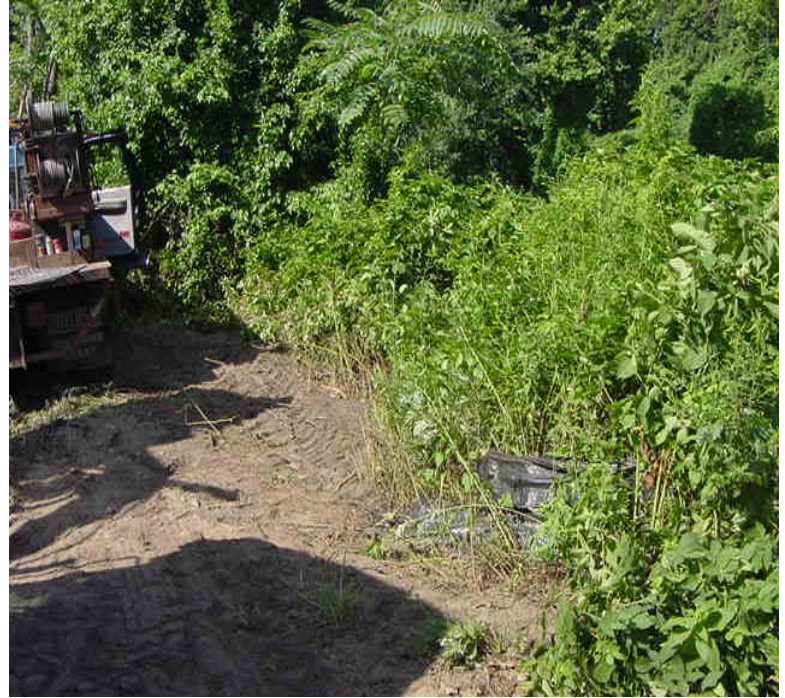
115 kV (Broad Street and ROW): Photo on the left shows work within Broad Street. Photo on the right shows the ROW near the substation where work has pushed over the silt fence 8/10/05

- Active work was near the Redding Country Club but silt fence has been repaired. 8/10/05	-Continue to maintain and repair fence where necessary when active work approaches an area. 8/10/05
Broad Street and Rt. 7, Norwalk	-Work near the substation on the ROW has resulted in some fence knocked over near the caisson drilling and a low spot in the grade needs to be toed in. Also, debris and brush should be cleaned up from the ROW, especially where it was placed beyond the fence. 8/10/05	- Repair the downed area and maintain and toe-in silt fence until the ROW stabilizes. 8/10/05

- Broad Street work had several small associated piles of soil. If they are to be left on the shoulder beyond the end of the day, silt fence should be installed. 8/10/05	- Perform regular “good housekeeping” to remove leftover materials and clean up the workspace. Use the silt fence as limits of work and do not place materials beyond. 8/10/05

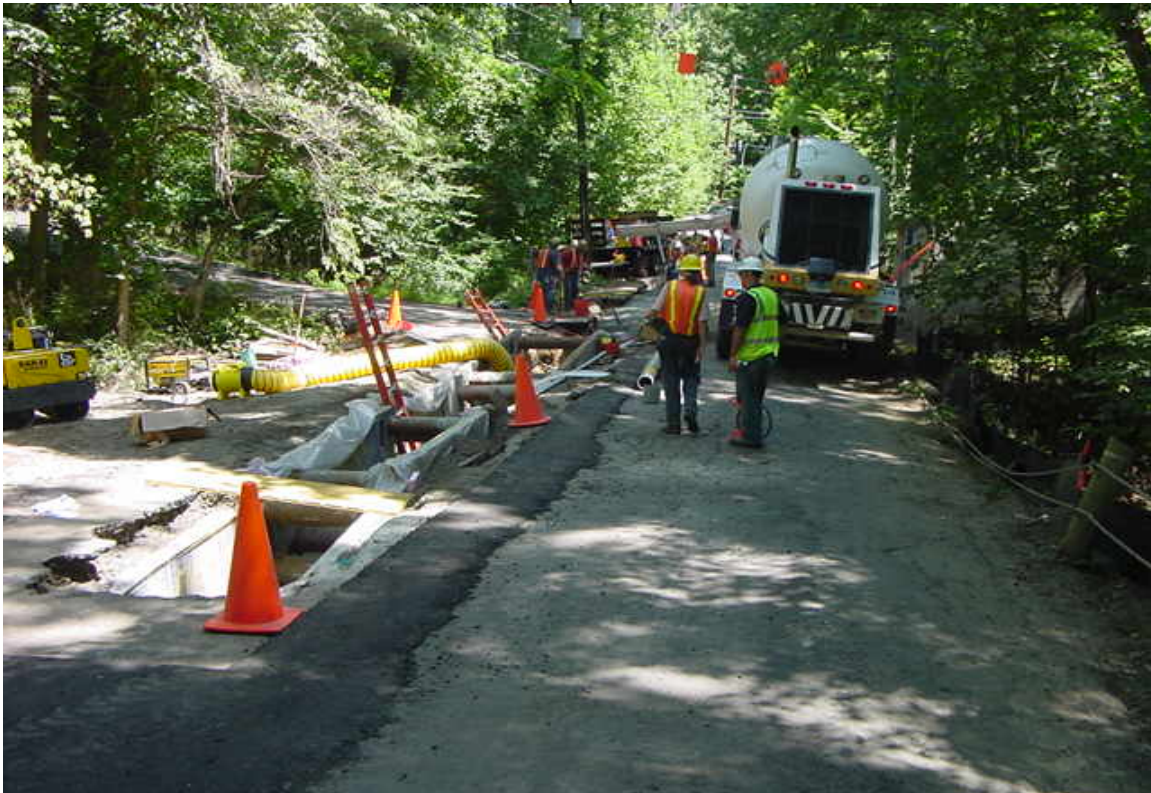
115 kV (Gallows Hill Road): General view of the trenching ongoing near #116. Keep erosion control in good repair and clean up pull off area when work is complete. 8/10/05

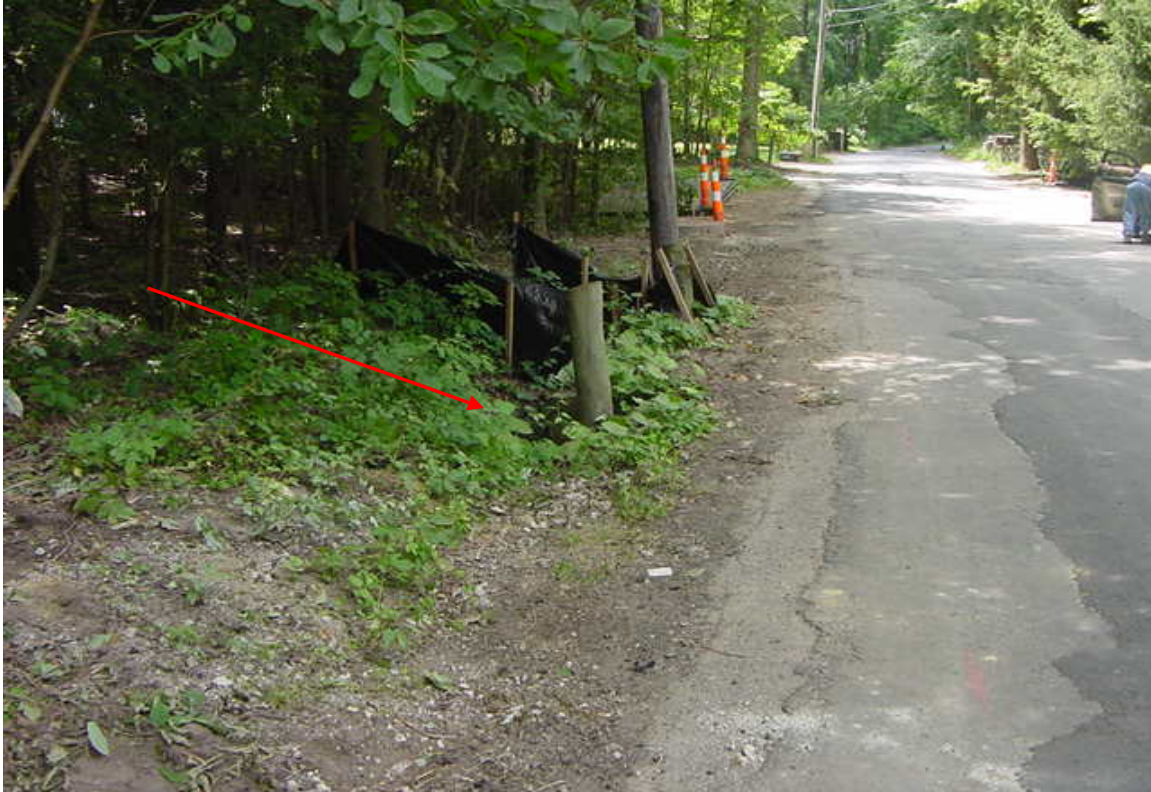
The inlet near #53 Gallows Hill Rd. will require silt fence or haybales on the other approach swale if active work returns to this area. Both sides drain to the inlet. 8/10/05

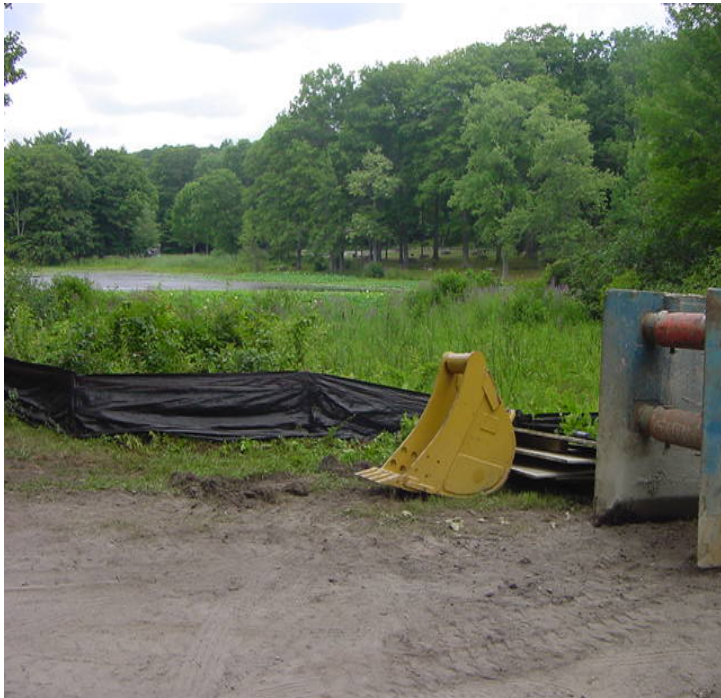
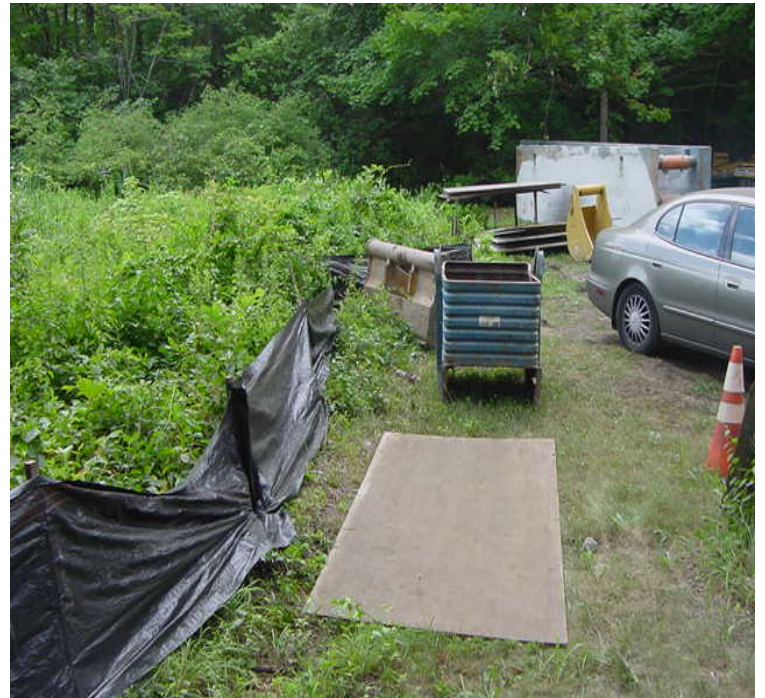
115 kV (Route 58 near Putnam Park): Silt fence was installed as recommended at the new storage area but it is encroaching on the wetland vegetation and is not toed in. 8/10/05

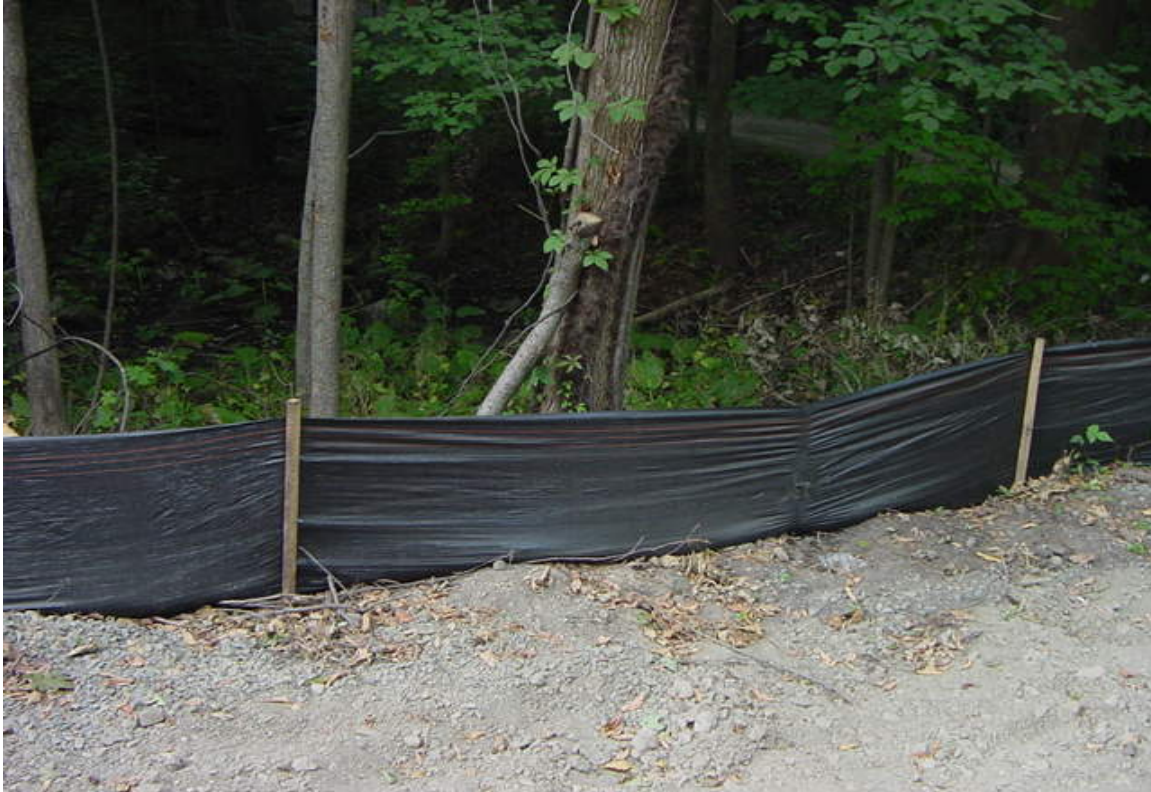
115 kV (Route 58 near Handhole 4): The silt fence repair made here was installed backwards. Stakes should be on the downgradient side of the fabric and the bottom toed in upgrade. 8/10/05

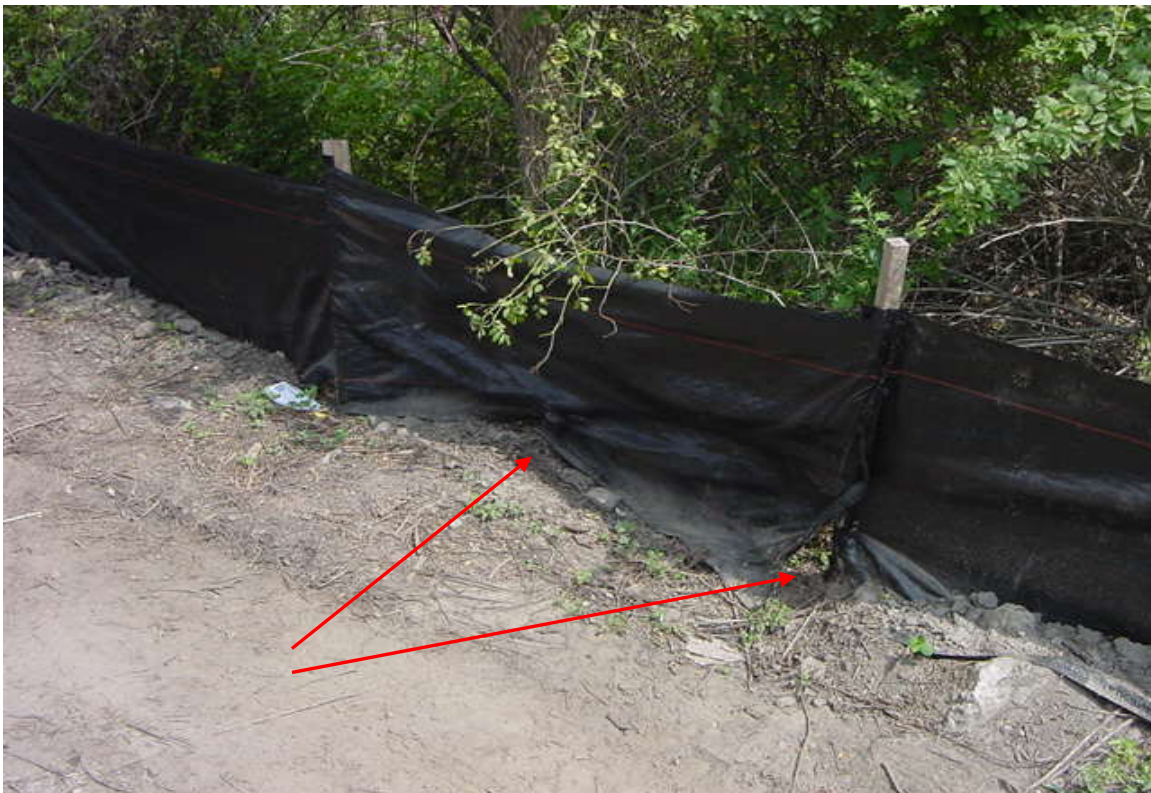
115kV (Route 58, near Hoyts Hill- Transition Pole): Silt fence along the dirt access road into the structure could use some repair and toeing in. 8/10/05

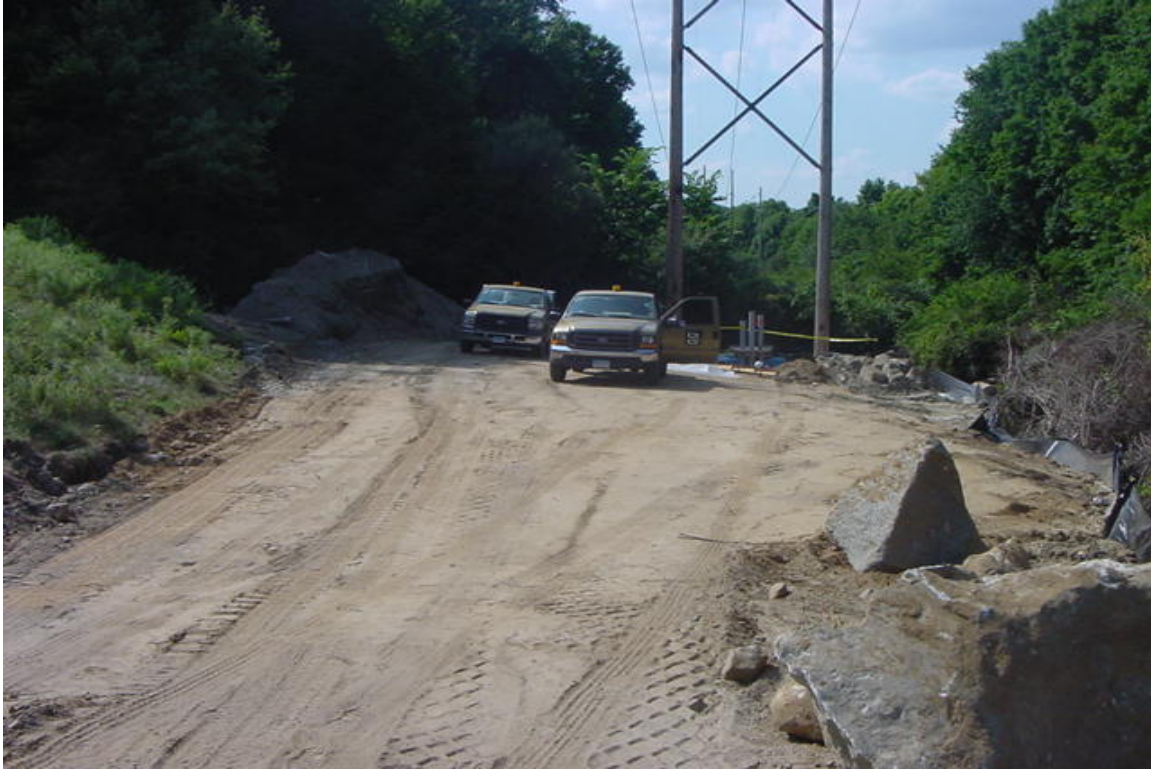
115kV (Bethel Education Park) View of the northern caisson location area. Some attention should be given to repair silt fence. (8/10/05)

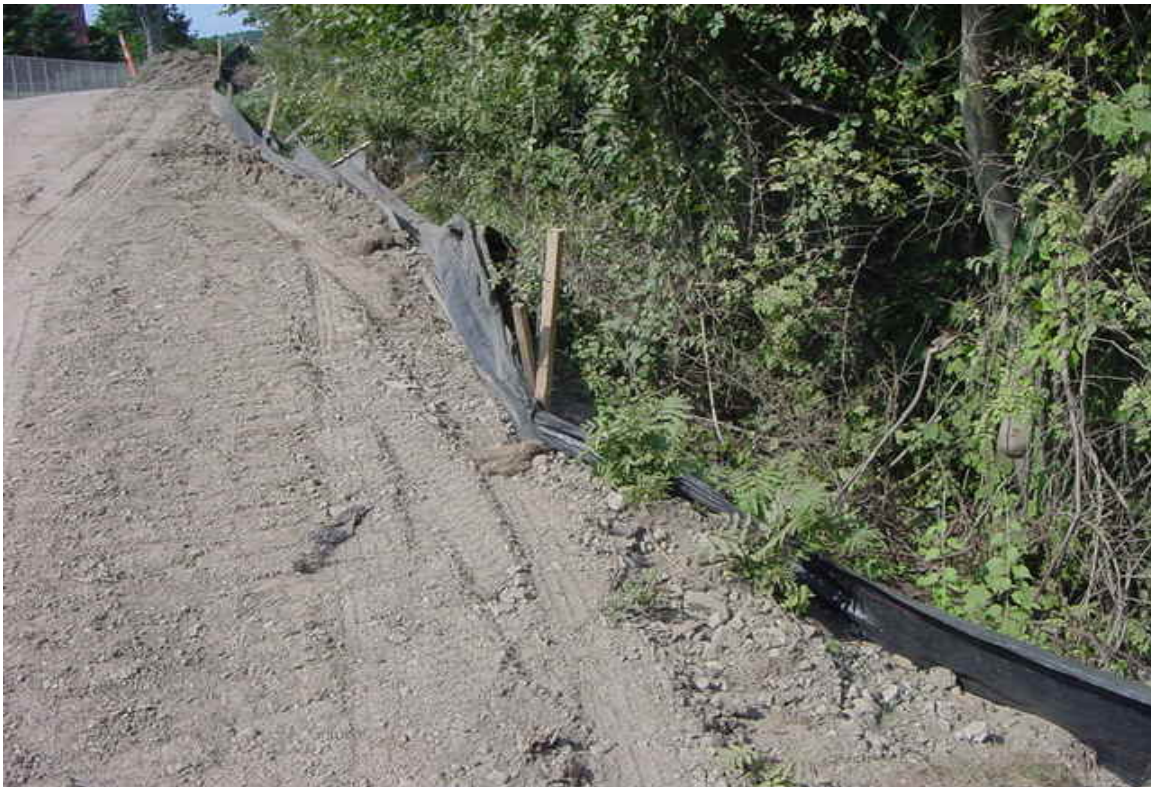
View of one of the areas along the southern portion of the ROW that requires silt fence maintenance and repair. Fence should be in good condition until the area is revegetated. 8/10/05

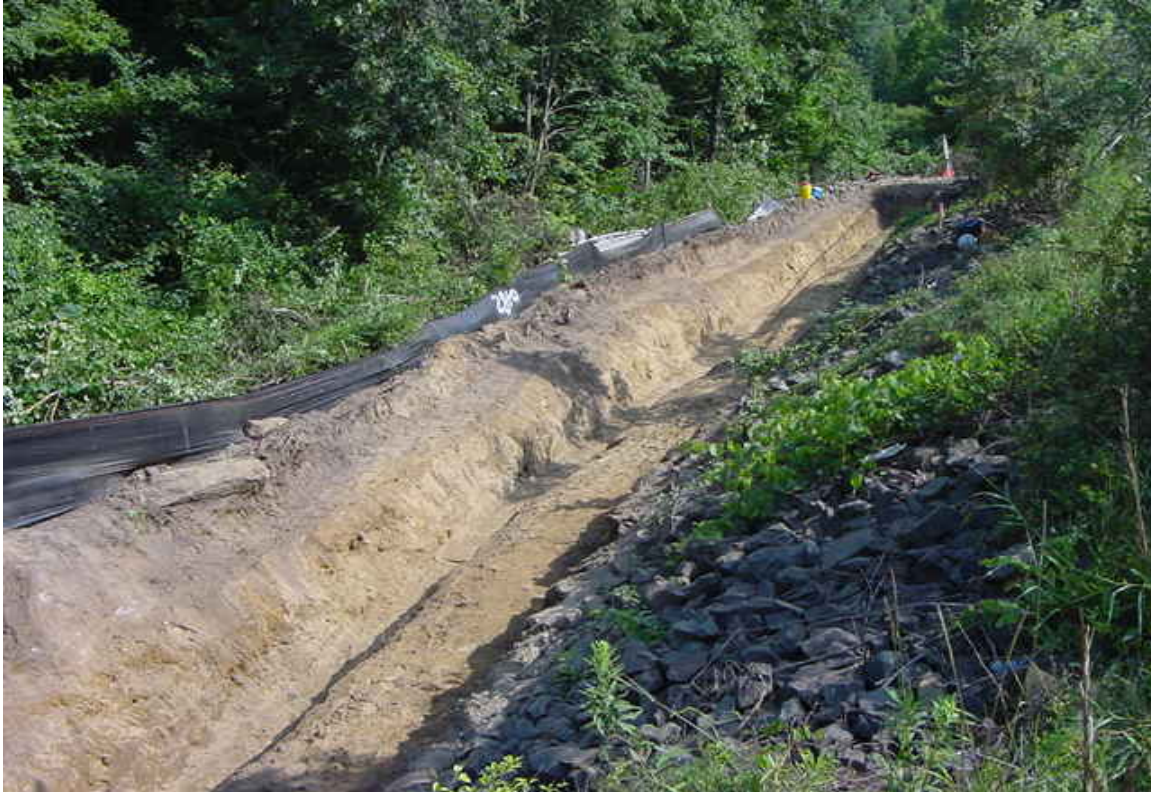
View of the active trenching along the ROW leading to the southern transition structure caisson. This is one of the last sections at the school to construct. 8/10/05

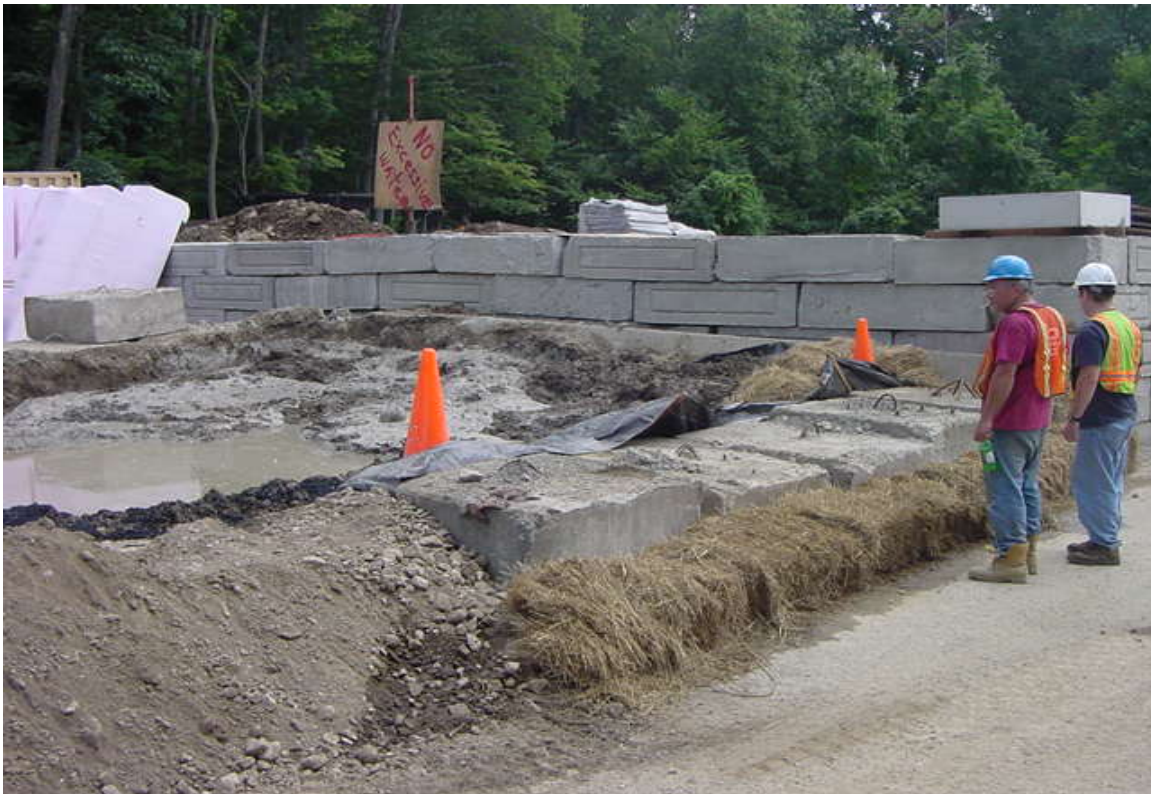
115kV (Redding Town Yard): Additional attempts to control the concrete washout area include placing filter fabric under and around the berm. This seems to have been effective. 8/10/05
